# Use of Energy-Saving Systems in Greenhouses at the Yair Research Station, Arava Valley (2008-2009)

Shabtai Cohen, Rivka Offenbach, Dorit Hashmonai, Dudu Elkayam, Avi Osherovitz - Central and Northern Arava R&D

Gad Asaf, Moshe Maroko - Agam Company

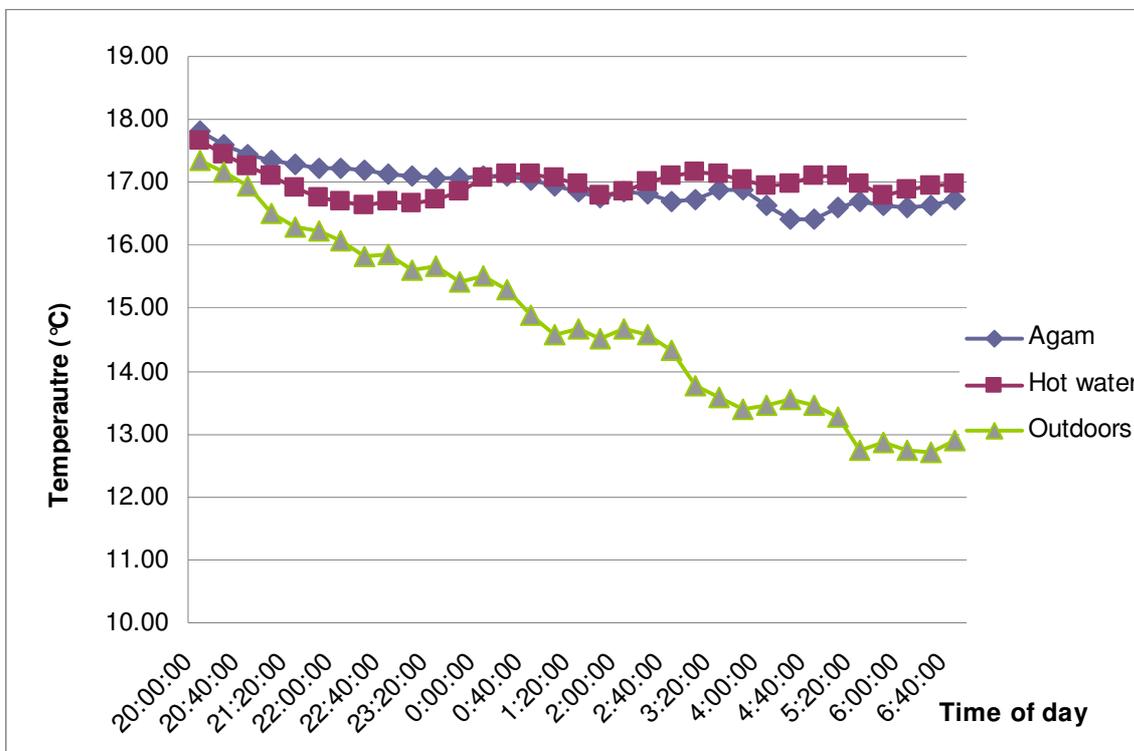
**Figure 4.** Comparison of the average air temperatures outside the Agam greenhouse (greenhouse 3) and those outside the greenhouse heated using the hot-water system (greenhouse 9). The data are averages for the hours between 20:00 and 7:00 on the following dates: Jan. 19, 23 and 27, and Feb. 3, 4, 16, 20, 23, 24, 27 and 28. These dates were chosen because, on these dates, the screens in the two greenhouses were in the same position (rolled up/spread out).

**Energy consumption-** The comparison of the energy consumption in the Agam greenhouse and the amount of energy consumed in the greenhouse heated using the hot-water system is presented in Figure 5. The average heat loss for the Agam greenhouse (greenhouse 3) is given by the transfer coefficient of  $3.53 \text{ W/m}^2$ , as compared to  $8.7 \text{ watts per m}^2$  for the hot-water heating system. The relationship  $3.53/8.7 = 40.6\%$  expresses the amount of energy consumed in the greenhouse equipped with the Agam dryer, as compared to the amount of energy consumed in the greenhouse heated with hot water. Heating with the Agam unit provided a  $59.4\%$  savings in the amount of energy consumed, as compared to the energy consumption in the greenhouse heated using hot water (see Figure 5). It should be noted that last winter was warmer than average and the heating systems did not need to work at their full capacities. The greenhouses needed to be heated to about 4 degrees above the outdoor temperatures (Figure 4), while these systems are capable of reaching much greater differences.
